Comments on Draft Report for Hugo

Re: Western Farmers Electrical Cooperative  
Hugo Power Plant  
Comments on Assessment of Dam Safety of  
Coal Combustion Surface Impoundments

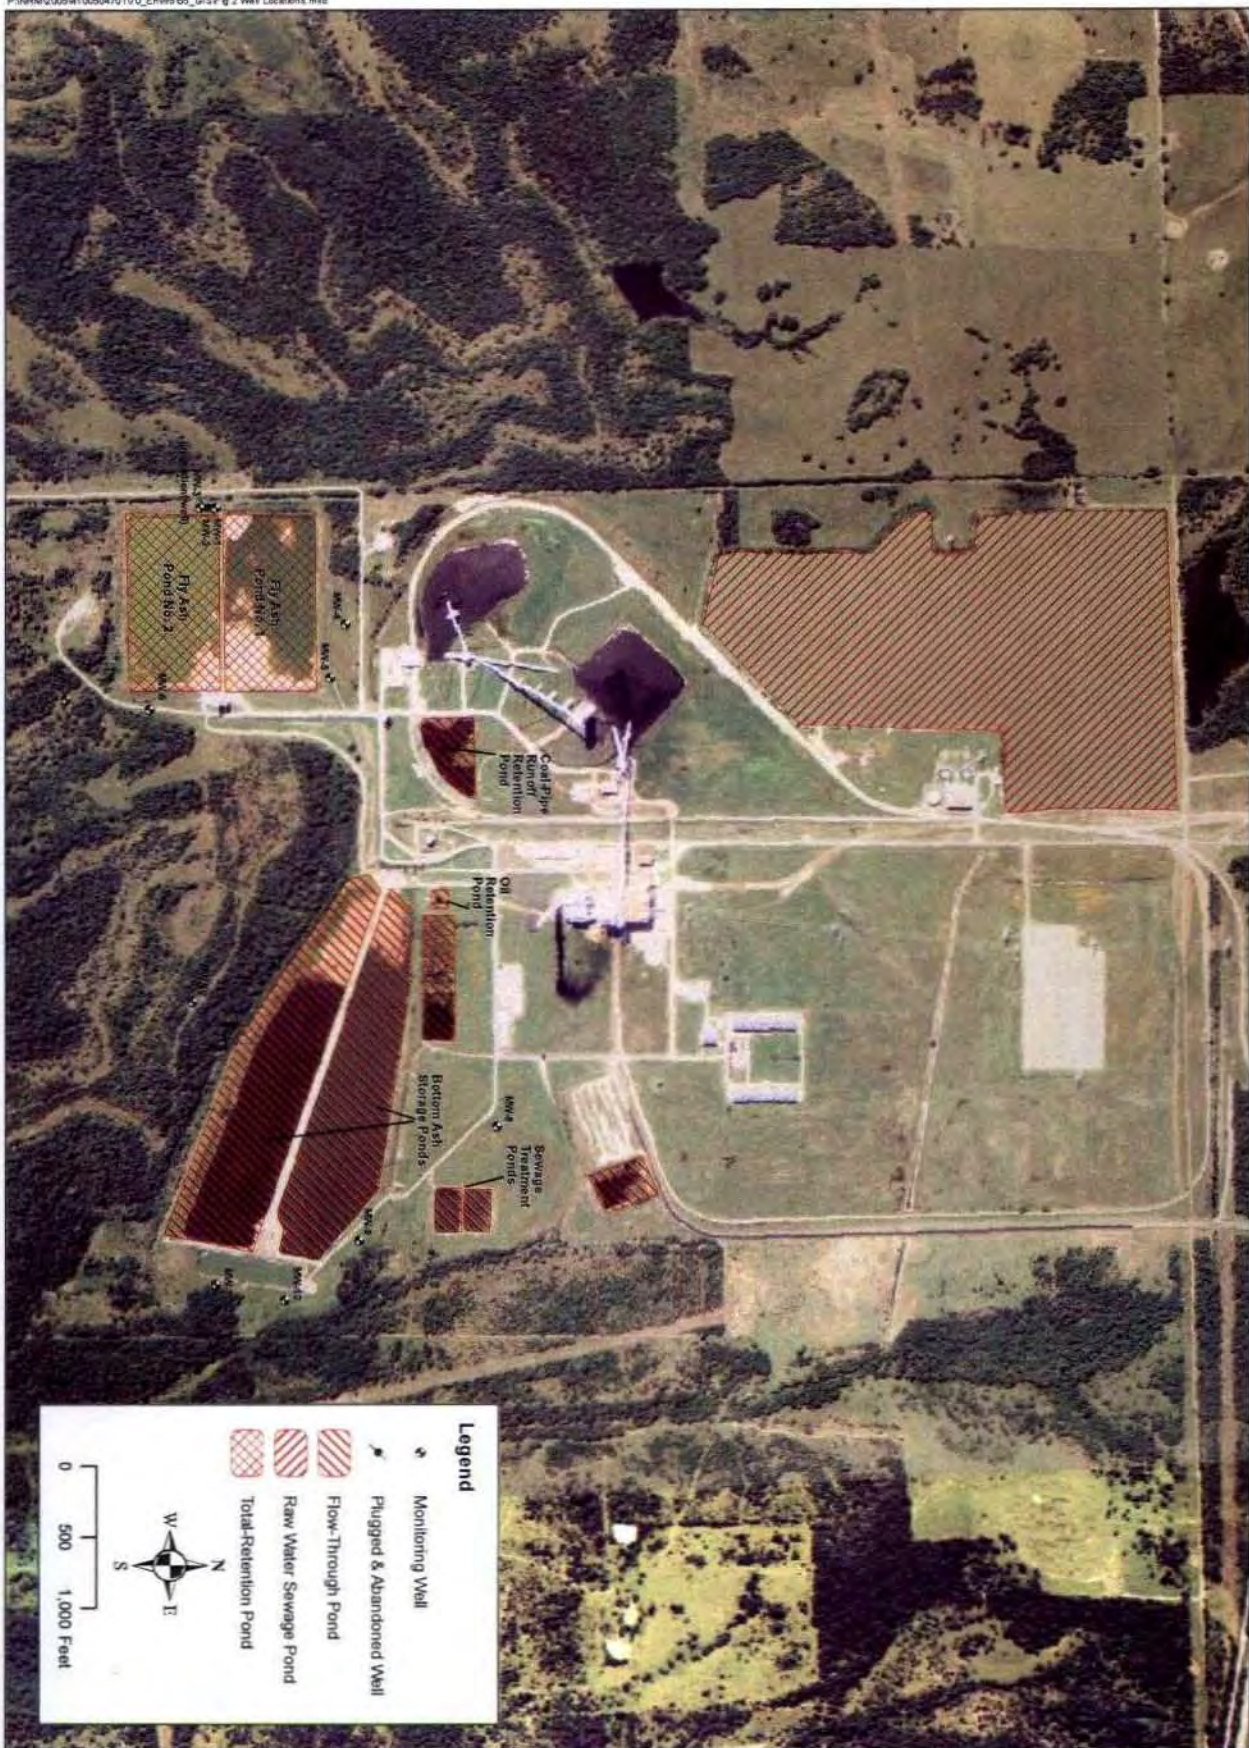
**Figure Title**  
**Site Layout and Well Locations**

The section states there are two monitoring wells at the site. Actually there are 11 monitoring wells at the site. There are two (2) up-gradient wells and nine (9) down-gradient wells. Of the nine (9) down-gradient wells, five (5) are down-gradient of the fly ash impoundment and four (4) are down-gradient of the bottom ash impoundment. A drawing is attached showing the approximate location of the monitoring wells.
